2004 VEGETATION MONITORING REPORT FOR SALT MARSH RESTORATION PROJECTS

Stephen M. Smith
National Park Service,
Cape Cod National Seashore
99 Marconi Site Road,
Wellfleet, MA 02667

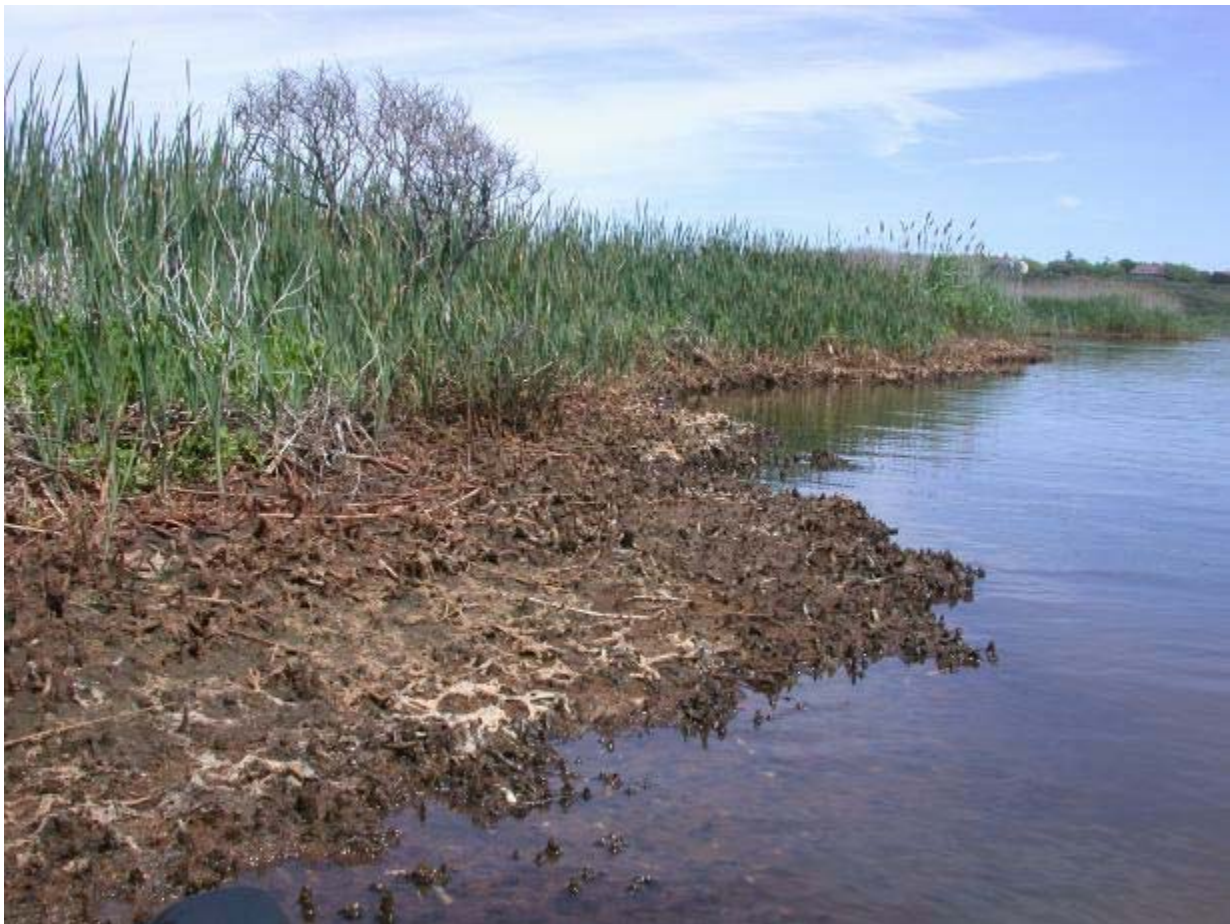
Figure 7. Salt-killed zone of vegetation along the north shoreline of East Harbor (2004).

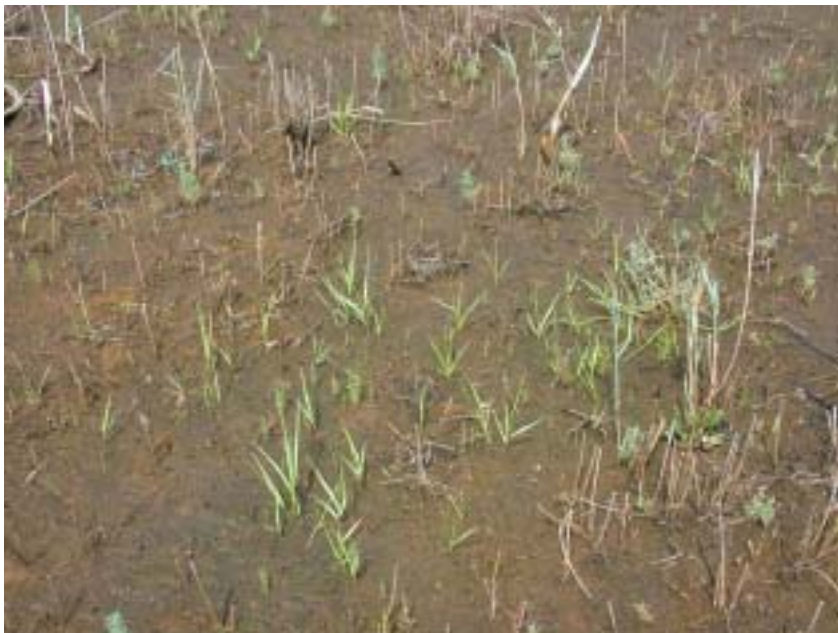
Figure 2. Seedlings of *S. alterniflora* germinating on a mudflat amidst stunted and dead *Phragmites* stems.

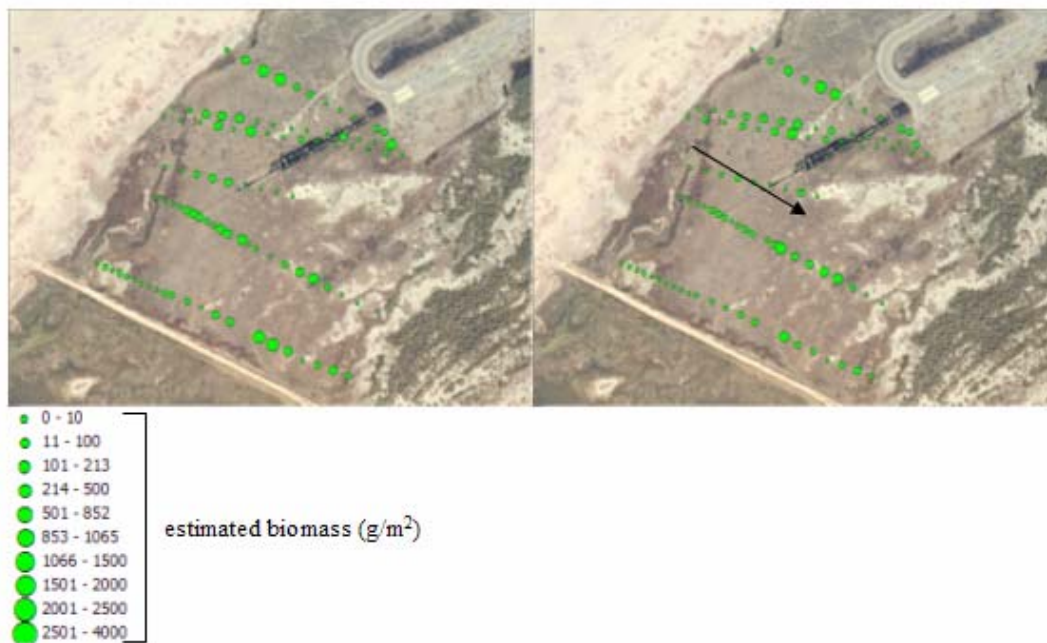
Figure 9. Changes in *Phragmites* biomass (estimated from stem heights and densities) from 2002-2004 (arrow indicates direction of movement of peak biomass).

From a marsh-wide perspective, *Phragmites* is responding to increased tidal influence primarily by shifts in its distribution (Figure 9). While *Phragmites* near the main tidal creek is disappearing or exhibiting stunted growth, the far edge of the population is encroaching upon the freshwater wetland community behind it. In other words, Zone 2 (see Figure 10) of the population is moving away from the creek bank and toward the freshwater-upland transition zone, although the degree to which this is occurring is different along each transect. The largest change has occurred along transects 1 and 2, which experience the greatest amount of seawater influence owing to their close proximity to the culverts.
